HOBOKEN PIER A SUBSTRUCTURE REHABILITATION  
HOBOKEN, NEW JERSEY

**ADDENDUM NO. 03 – SEPTEMBER 7, 2016**

# HOBOKEN PIER A STRUCTURAL ANALYSIS & FEASIBILITY STUDY - SELECTED PORTIONS

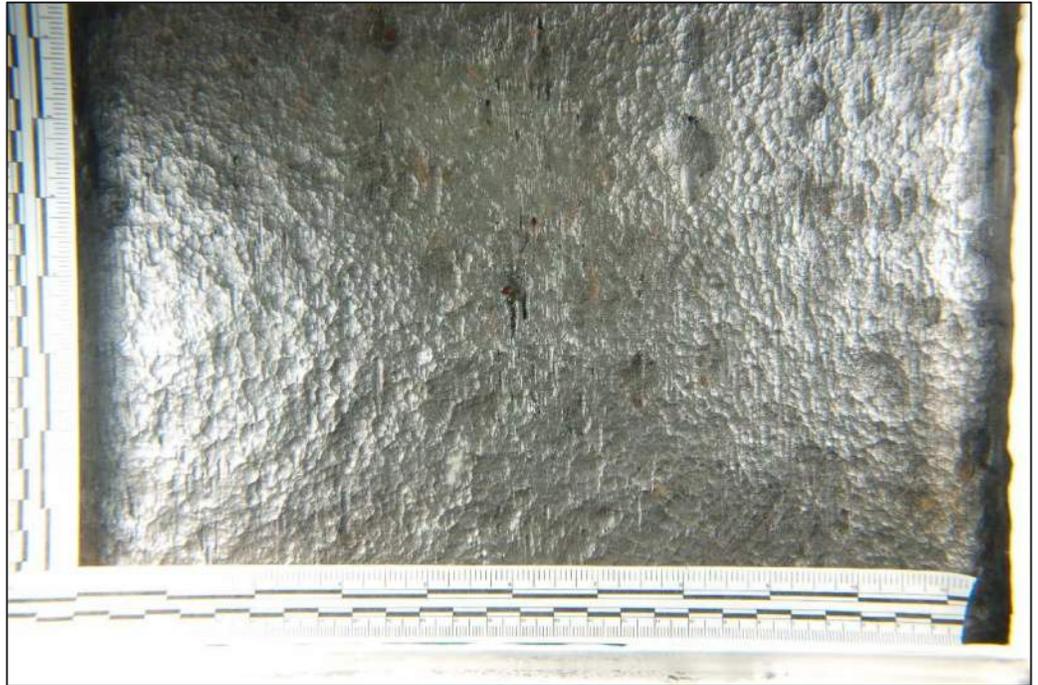
The concrete encased H-Piles throughout the structure have widespread major to severe deterioration. Primary major to severe deterioration mechanisms include exposed steel H-Piles below the concrete encasement with heavy pitting, section loss, isolated perforations through the flanges, and voiding of the concrete encasement topping (See Photograph 7 to Photograph 9). Isolated piles have voiding of the concrete encasement (See Photograph 10). Moderate to major deterioration mechanisms observed include erosion of the concrete encasement, scour of the concrete encasement with no exposed steel, and vertical cracking through the encasement (See Photograph 11 and Photograph 12).

*Photograph 7 – Heavy pitting at Pile 43N-3.*

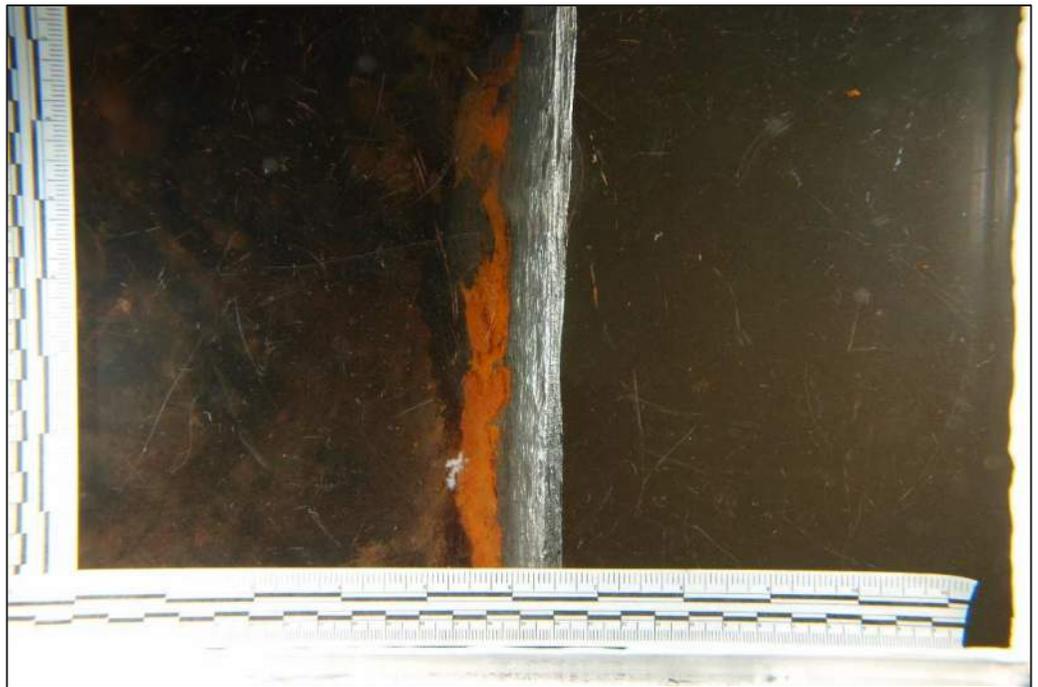
*Photograph 8 – Significant section loss of flange edge at Pile 43N-3.*

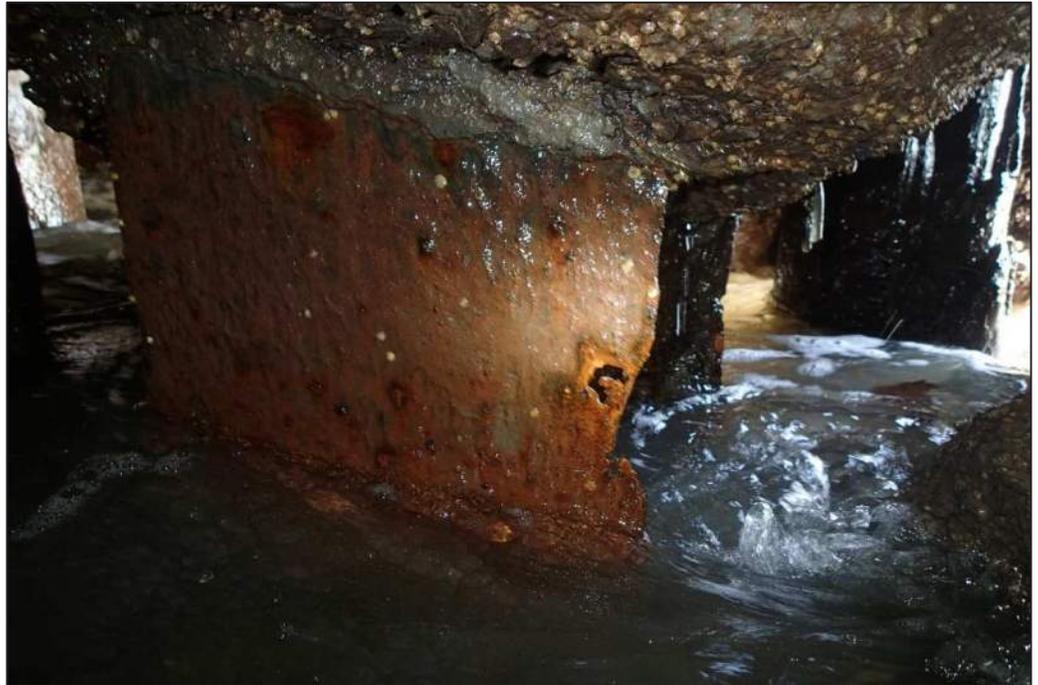
*Photograph 9 – Severe corrosion perforations through flange at Pile 10N-1.*

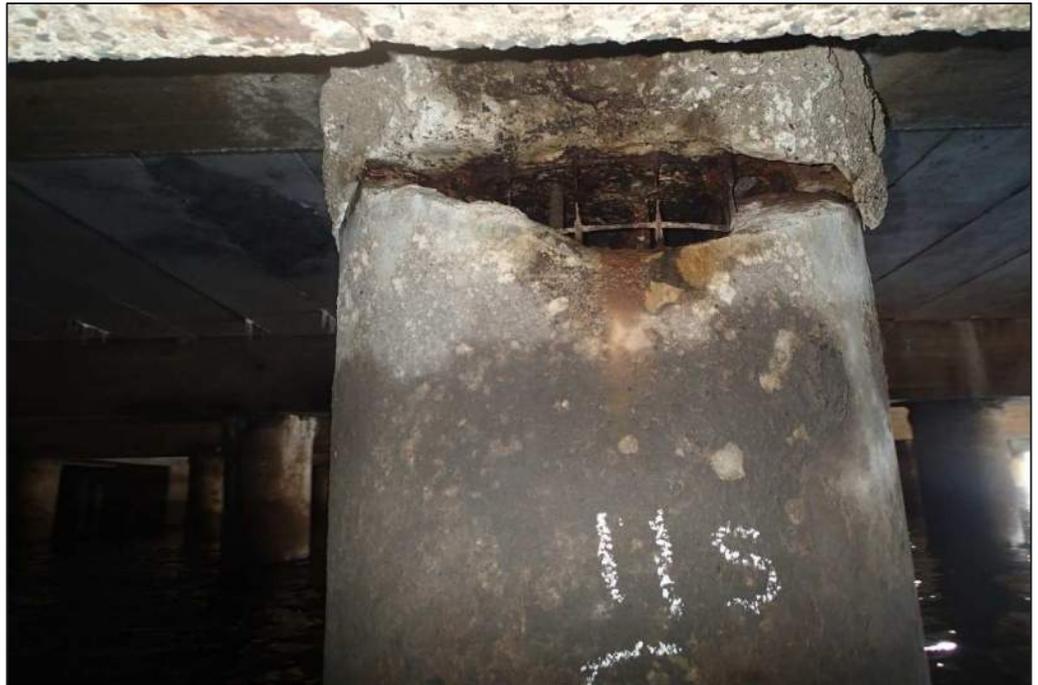
*Photograph 10 – Voiding of concrete encasement topping exposing structural steel at Pile 11S-5.*

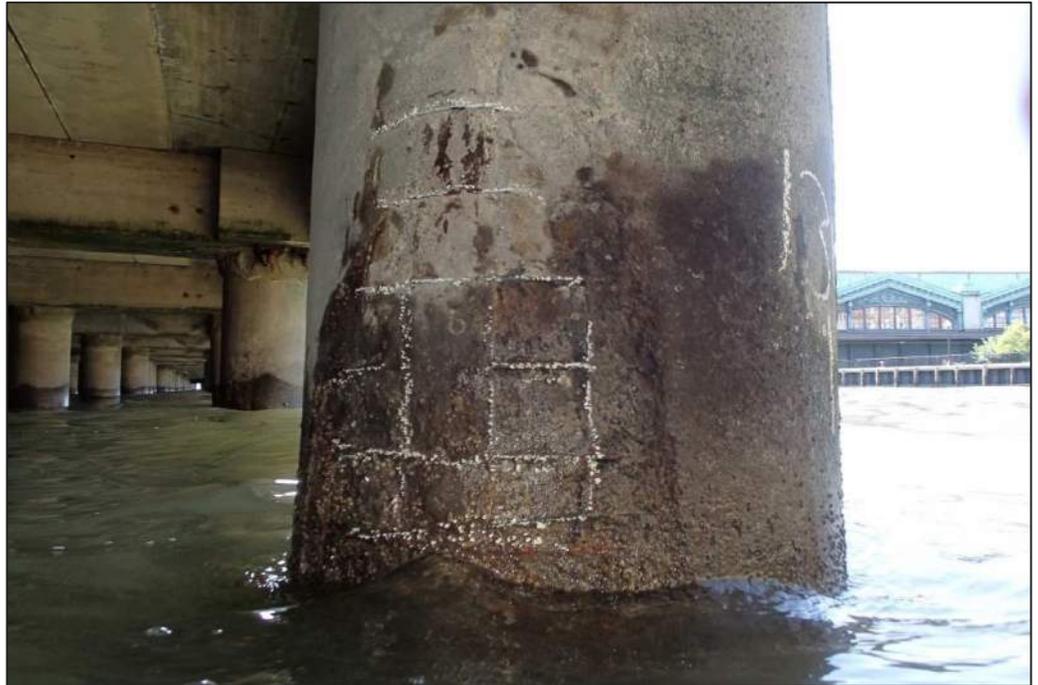
*Photograph 11 – Encasement erosion with exposed welded wire reinforcement at Pile 13S-1.*

Encasement erosion, vertical cracking, and scour observed throughout the pier at isolated locations are deterioration mechanisms, which will continue to progress and will need to be addressed in the future. The erosion and vertical cracking observed provides chloride intrusion paths. Chlorides, along with oxygen and water, are primary ingredients in the corrosion process. Once corrosion has begun within a reinforced concrete structure, rapid deterioration and expensive repairs typically follow.

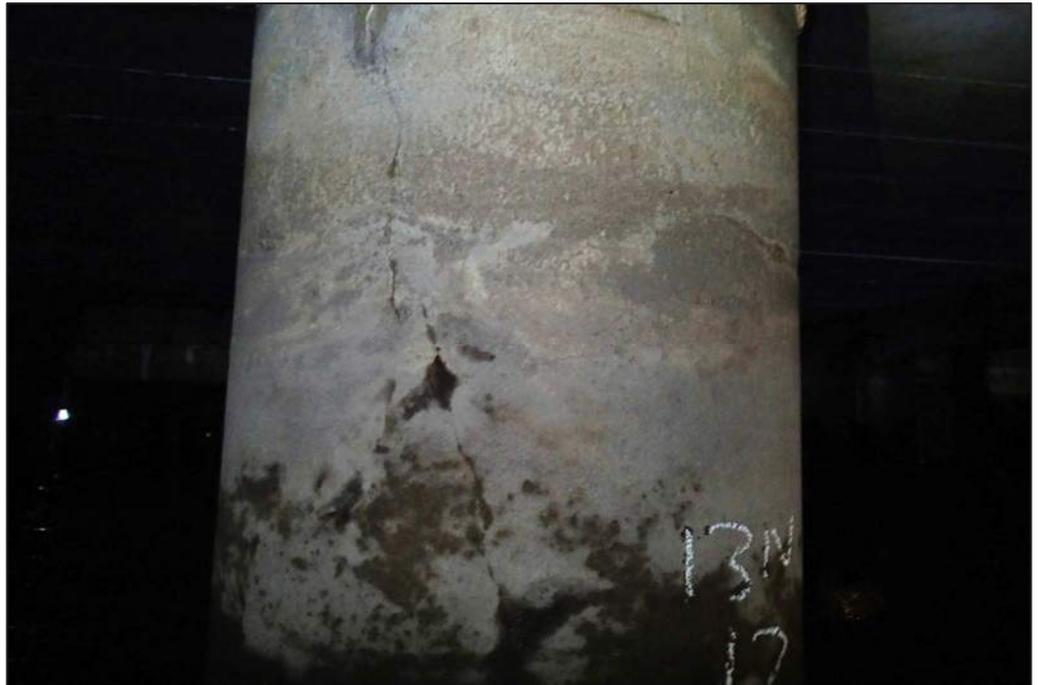
*Photograph 12 – Vertical cracking at Pile 13M-12.*

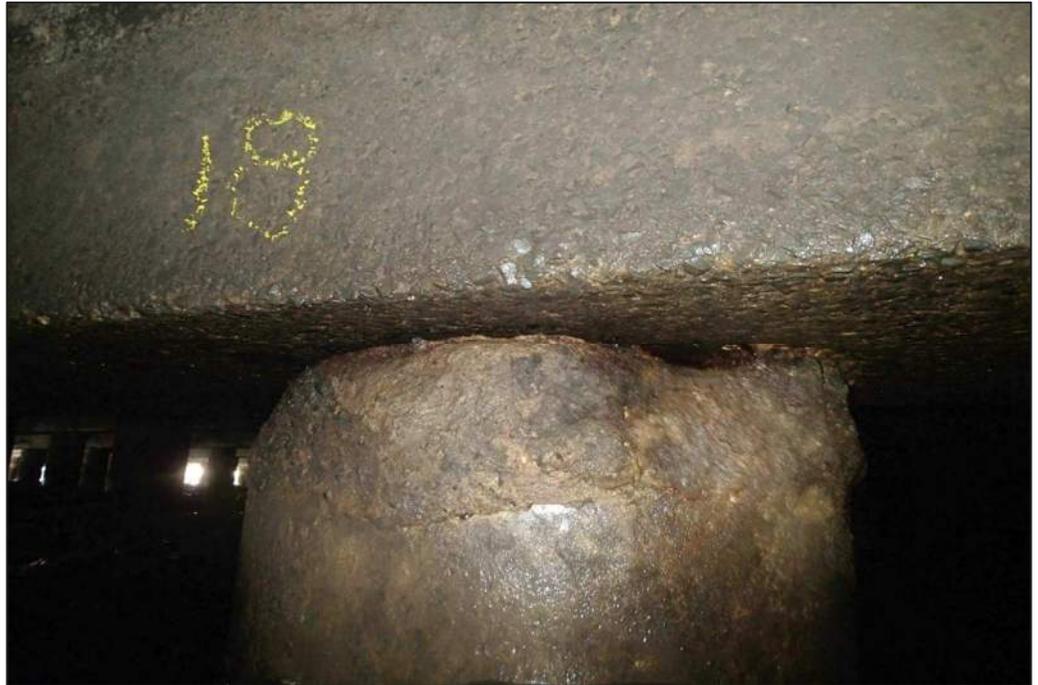
The concrete encasements appears to have been originally topped with shotcrete (gunite), which is a concrete placement method where cementitious mixture is sprayed into place with a compressed air powered nozzle "gun". Based on the inspection observations for piles below the "RR Well", this topping appears to have eroded over time and exposed the structural steel to further corrosion damage. In this area, the lower pile cap supporting the "RR Well" places the pile topping elevation below mean high water (MHW). This exposes the pile toppings to higher wave, current, and salt water exposures than adjacent piles. These are all mechanisms which drive erosion and voiding deterioration. Overall, approximately 72 percent of the piles within this area have erosion or voiding occurring (See Photograph 13). Limited access was available to assess the extent and condition of exposed steel within the voids.

*Photograph 13 – Typical concrete topping voiding at Pile 24S-18.*

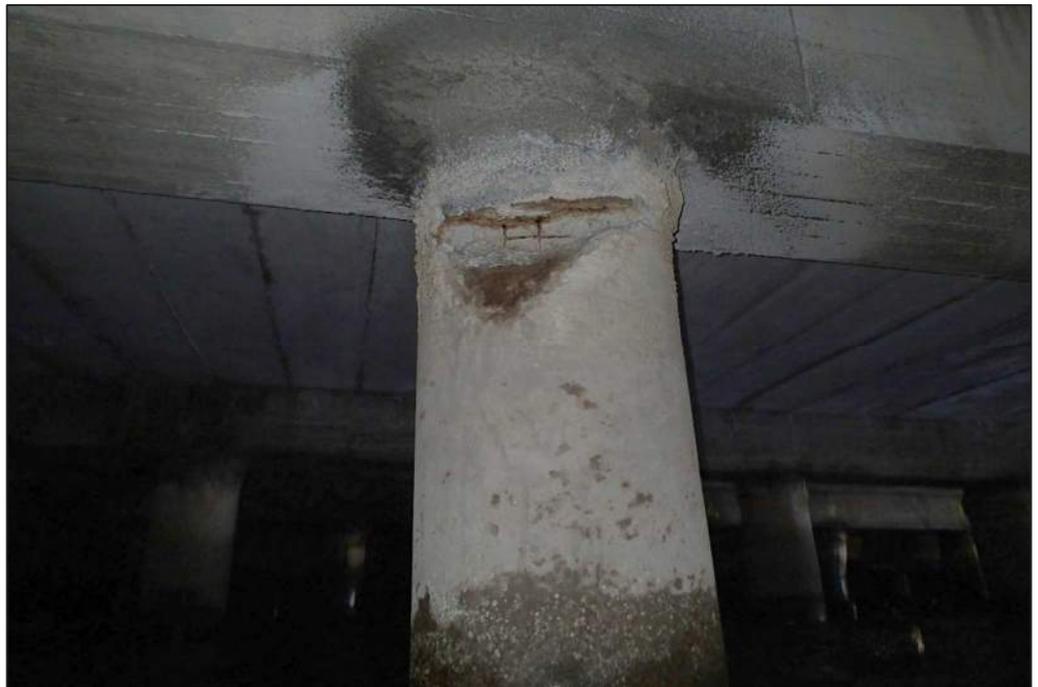
Additional voiding is present at the top, middle, and bottom of isolated concrete encasements. These voids are due to formwork and/or placement defects caused during installation where concrete fill was lost and/or not properly set during installation. As a result, voids have formed and, on isolated elements, are exposing the structural steel to corrosion deterioration (See Photograph 14).

*Photograph 14 – Concrete encasement voiding with exposed structural steel at top of Pile 13N-14.*

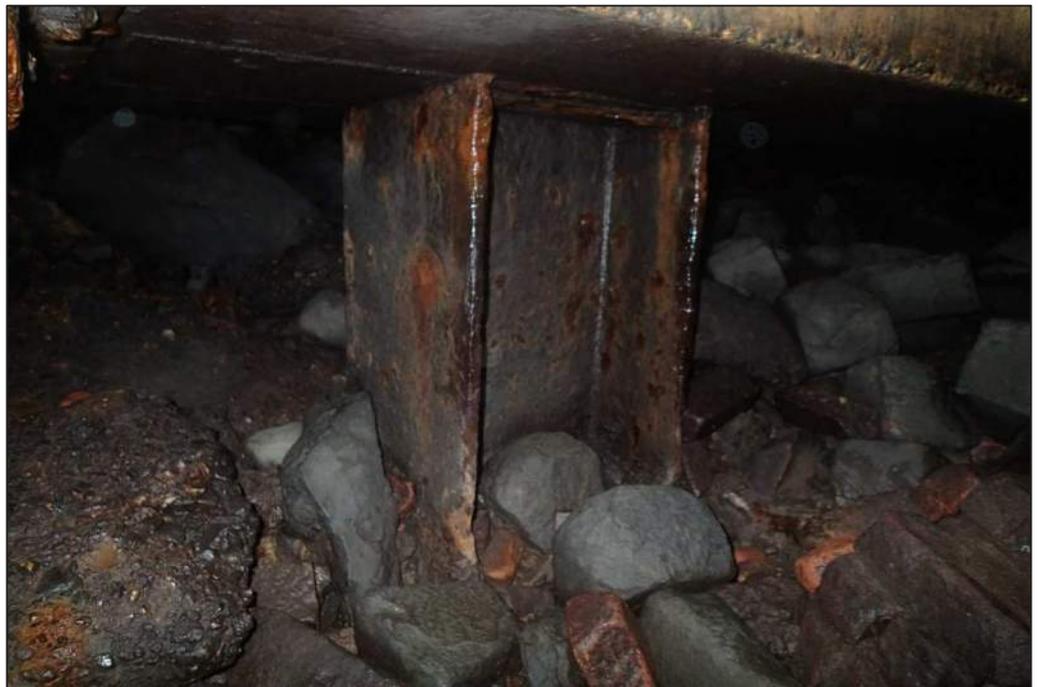
Finally, where steel H-Piles are exposed at the inshore extent of the pier, Bent 8N/S, the H-Piles typically have moderate corrosion (See Photograph 15).

*Photograph 15 – Typical moderate corrosion at exposed pile on Pile 8S.*

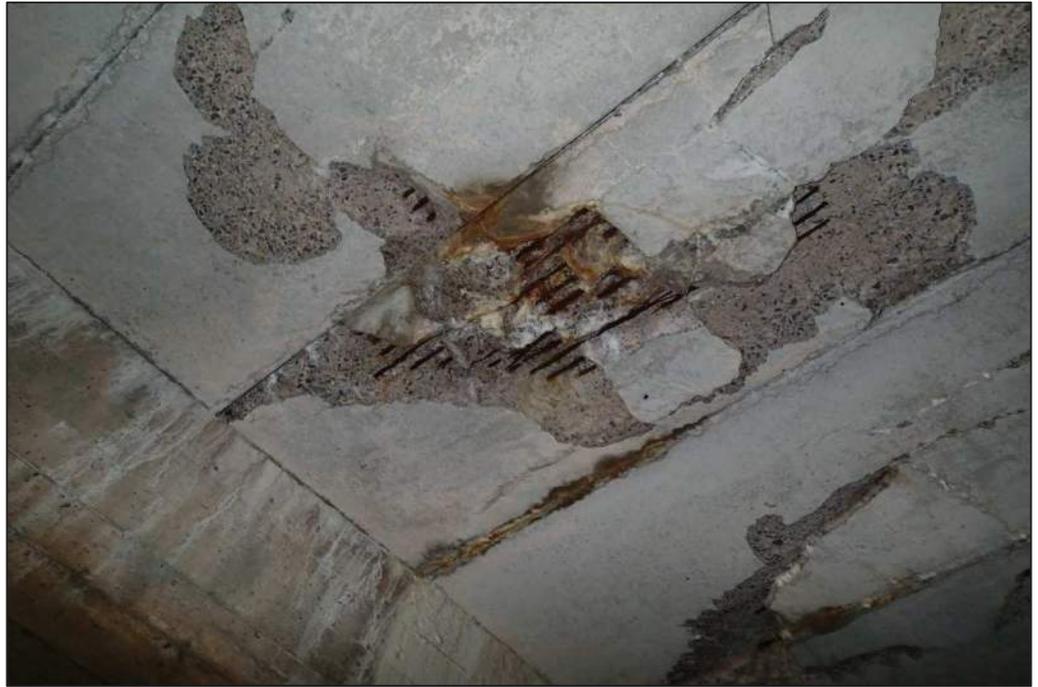
The Pier A superstructure is in typically moderate condition with isolated areas of major deterioration. Typical deterioration mechanisms include isolated spalling, corrosion cracking, heavy efflorescence, and mechanical damage (See Photograph 16 through Photograph 20). Additionally, top deck observations include displaced granite pavers due to plant growth between pavers and the concrete deck and displaced brick pavers (See Photograph 21 and Photograph 22).

*Photograph 16 – Isolated open spalling of concrete deck plank between Bents 11N and 12N. Note exposed and corroded prestressing strands.*

Approximately 315 square feet of open spalling is present on deck plank and edge beam locations throughout the pier. The majority of the observed spalling is present on precast deck planks between Bents 11N and 12N, as also noted in the 2011 Boswell Report. Open spalling occurs when corrosion of the internal steel progresses to a point when the concrete cover breaks away from the structure due to internal pressures. In these areas, internal steel, prestressing strands and/or reinforcing steel, are exposed to the saltwater environment. Where open spalling has exposed prestressing strands in the deck planks, the strength of the member has been compromised. Prestressed elements are more sensitive to corrosion damage and may require more substantial rehabilitation efforts to repair. Between Bents 12S and 14S hand-applied spall repairs have been installed to the underdeck, these repairs appear to be holding soundly (See Photograph 23).

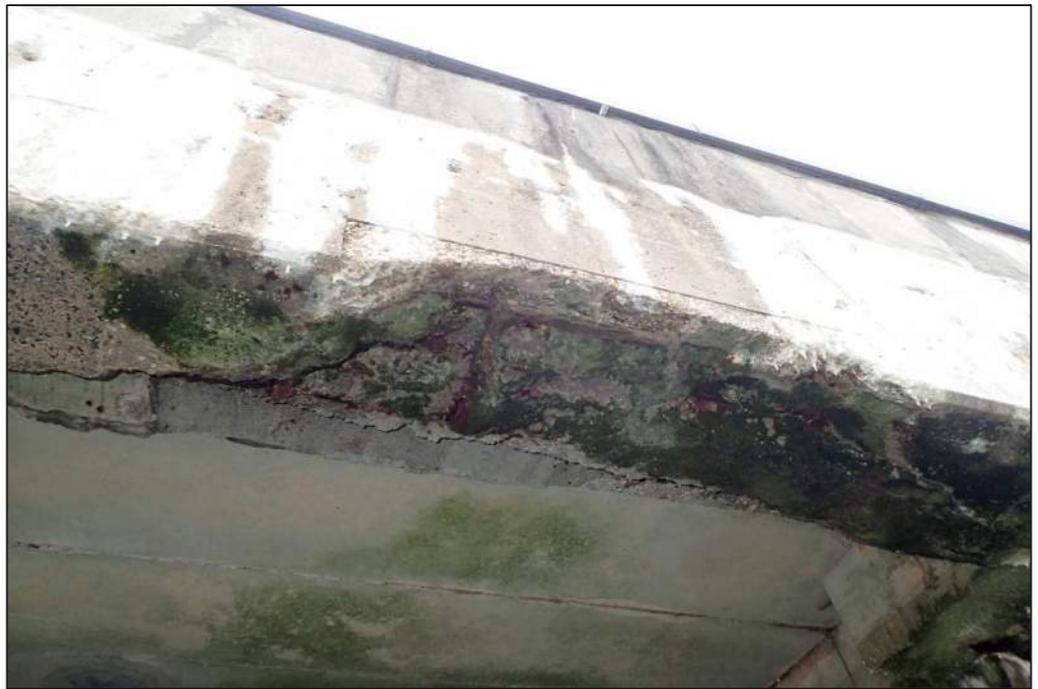
*Photograph 17 – Isolated open spalling of concrete edge beam between Bents 24N and 25N.*

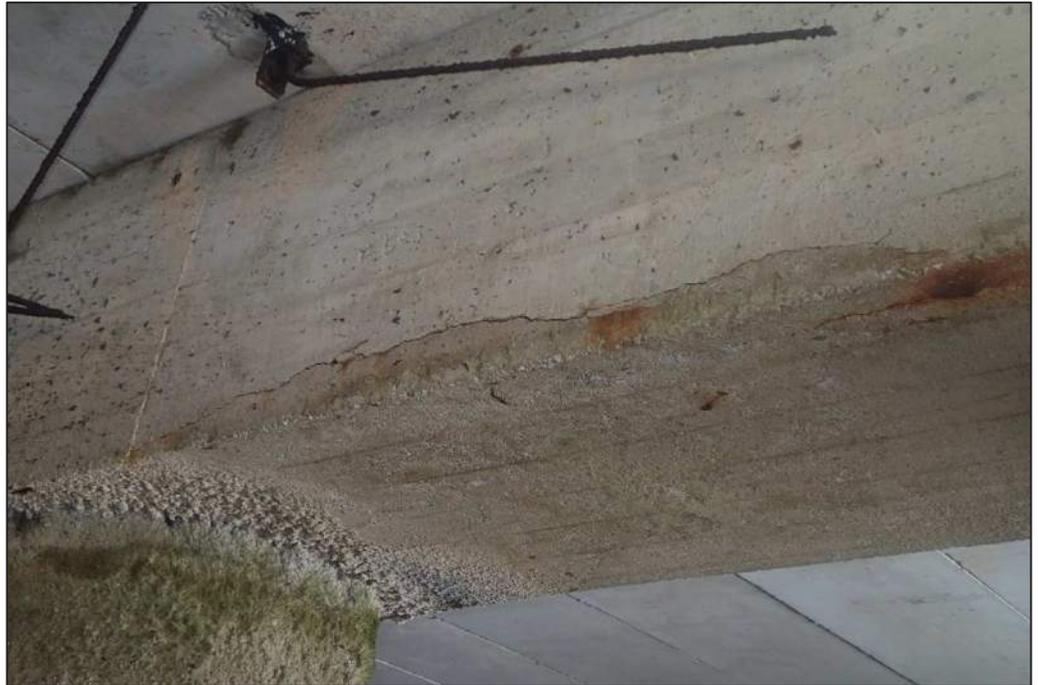
*Photograph 18 – Isolated corrosion cracking to concrete pile cap above 14S-4*

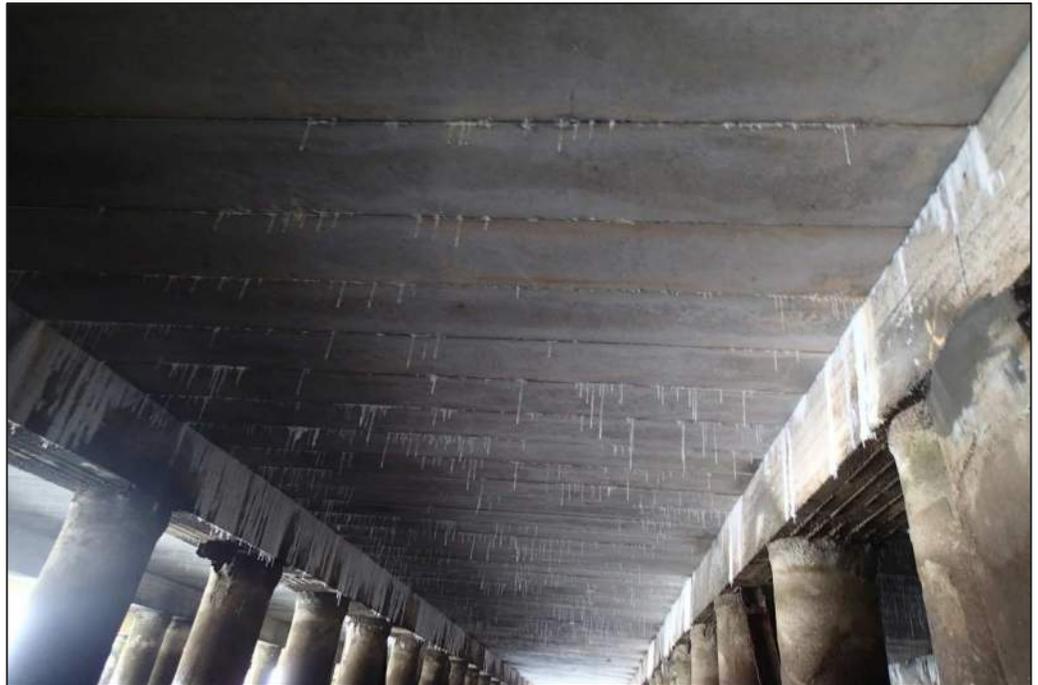
*Photograph 19 – Heavy efflorescence between Bents 41 N/S and 42 N/S.*

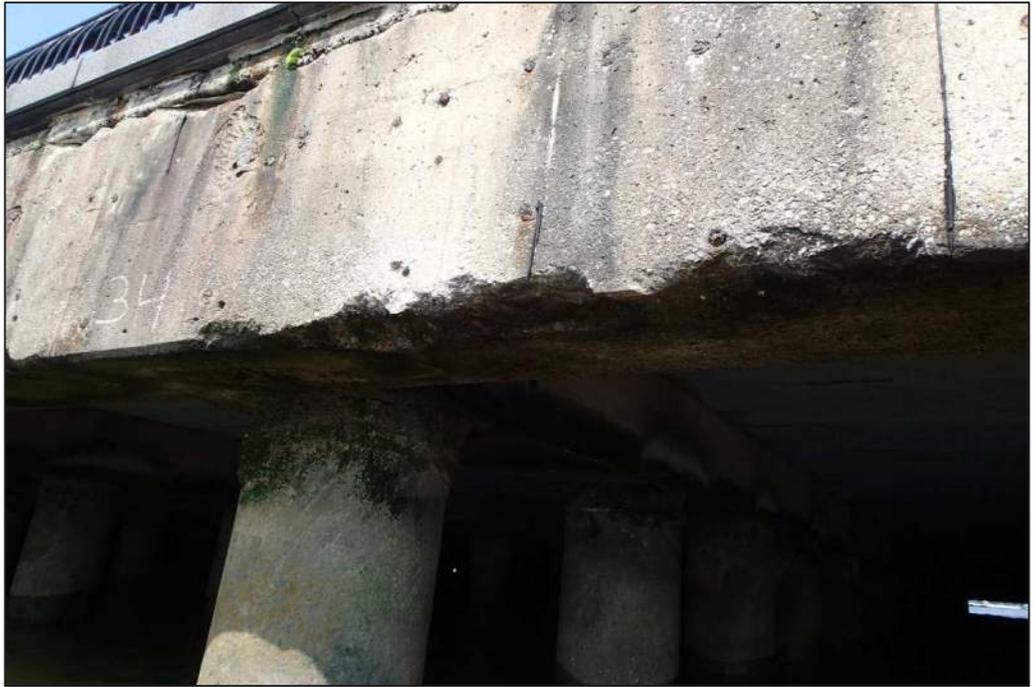
*Photograph 20 – Typical mechanical damage to edge beam above 34S-1.*

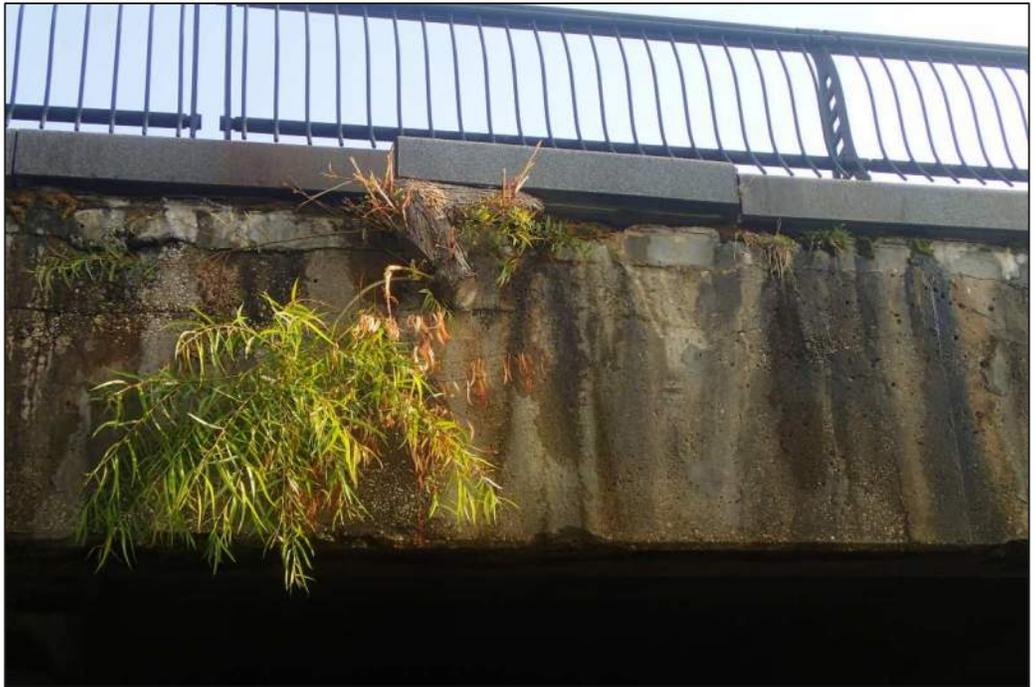
*Photograph 21 – Isolated displaced granite block paver above 16S.*

Displaced granite pavers are a potential pedestrian tripping hazard (See Photograph 21 and Photograph 22). Though these defects are not structural, they present a safety hazard and need to be addressed.

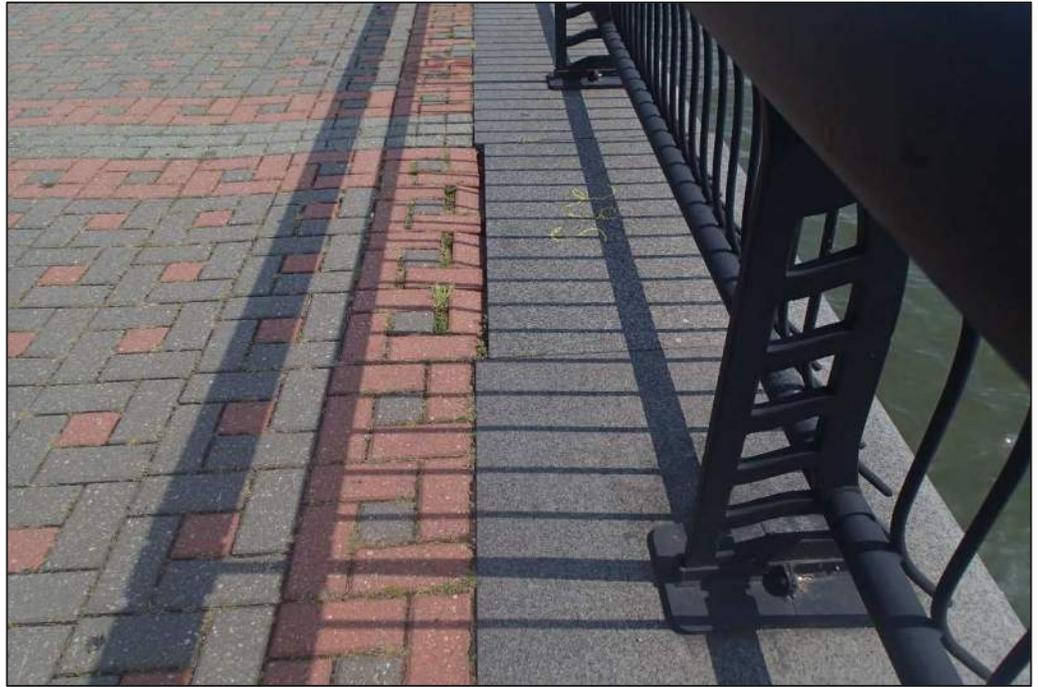
*Photograph 22 – Displaced brick pavers above 28S.*

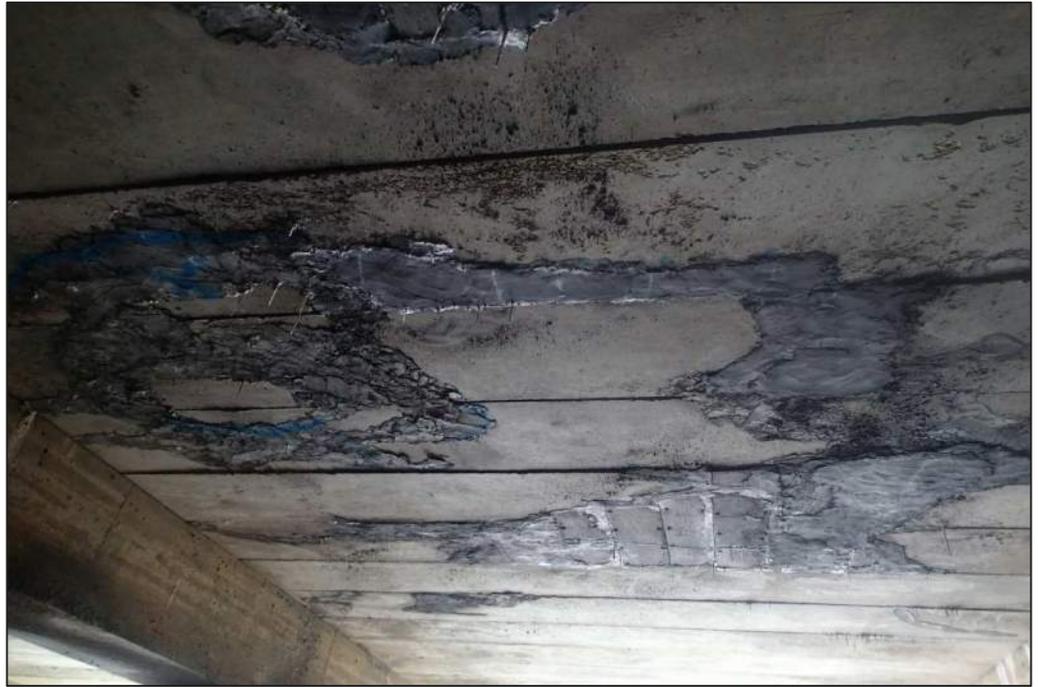
*Photograph 23 – Isolated hand applied spall repairs between 12S and 14S.*

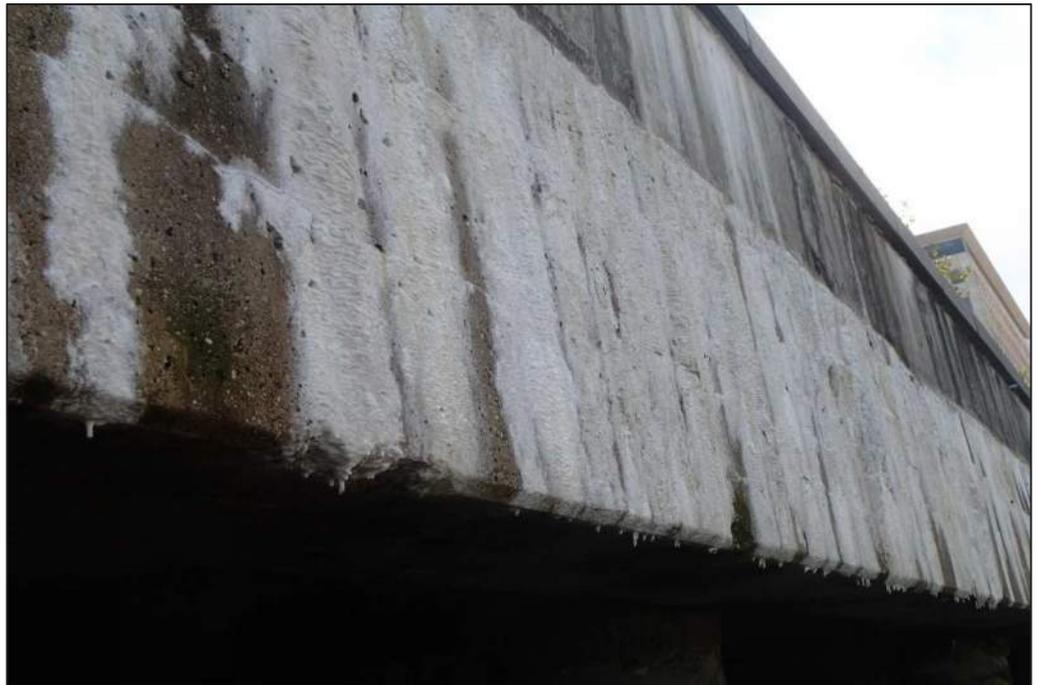
Observed corrosion cracking and heavy efflorescence cracking are providing a chloride intrusion path (See Section 3.2.2 and Photograph 24). These areas will continue to deteriorate over time and will ultimately become maintenance/rehabilitation items.

*Photograph 24 – Efflorescence cracking along northern edge beam (looking southwest).*
