HOBOKEN PIER A SUBSTRUCTURE REHABILITATION  
HOBOKEN, NEW JERSEY

**ADDENDUM NO. 03 – SEPTEMBER 7, 2016**

# HOBOKEN PIER A STRUCTURAL ANALYSIS & FEASIBILITY STUDY - SELECTED PORTIONS

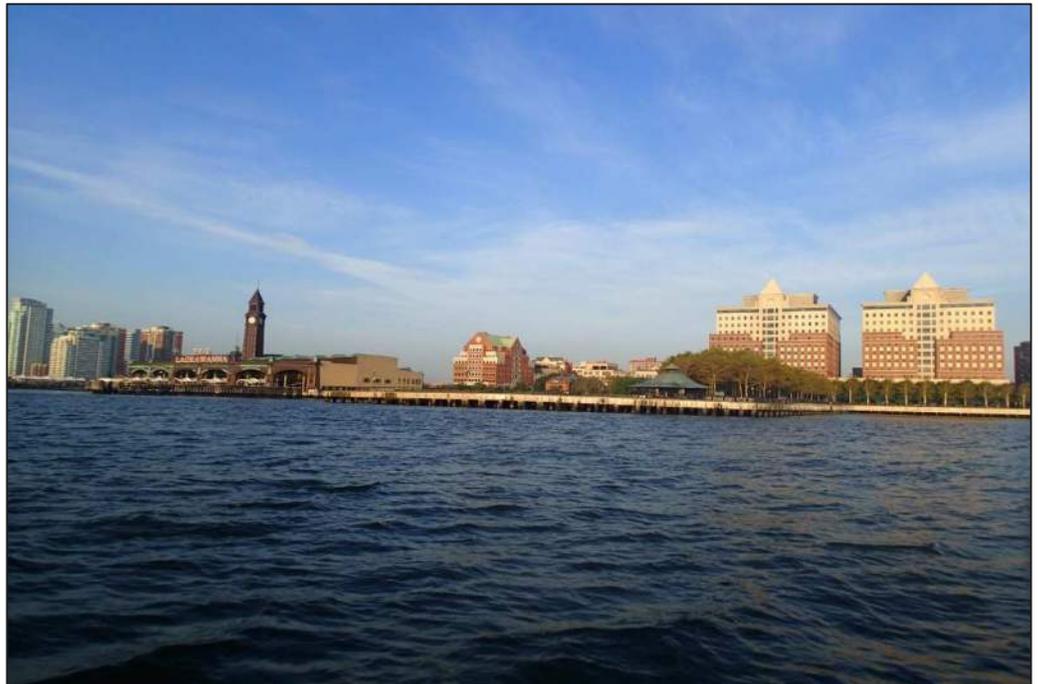
*Photograph 1 – Overview of Pier A (looking southwest).*

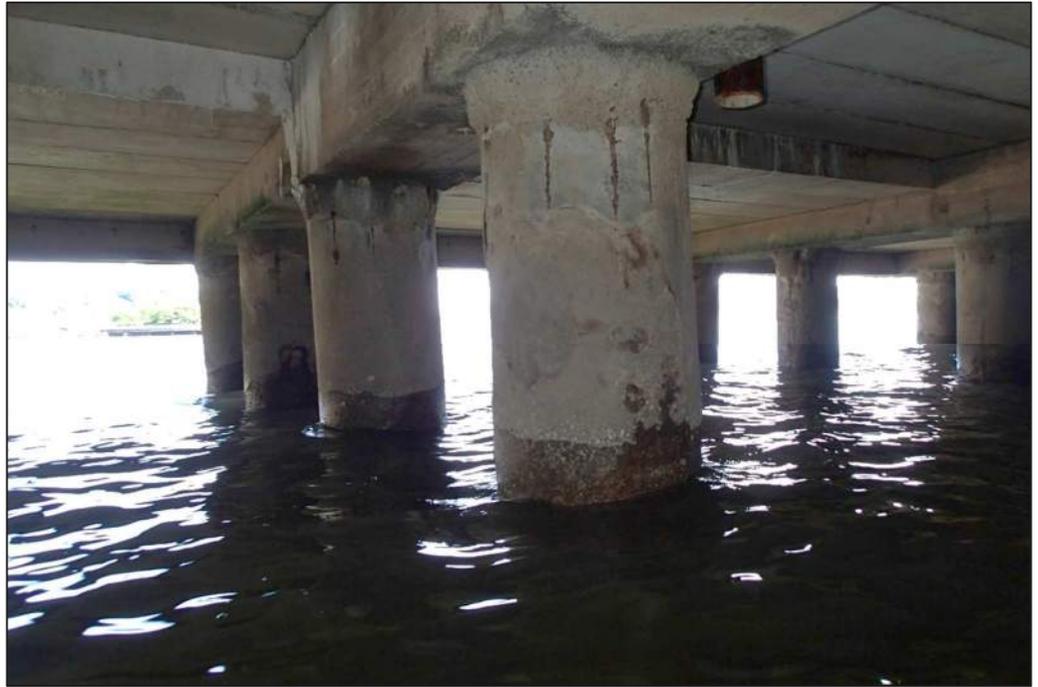
Concrete encasements have been installed at all accessible structural piles, 1,284 piles (See Photograph 2). These encasements extend from the pile caps down approximately ten (10) to twelve (12) linear feet, based on reference drawings. At locations where batter and plumb piles are in close proximity at the mudline (limited clearance for individual encasements), large concrete box encasements were installed.

*Photograph 2 – Typical concrete encasement above water.*

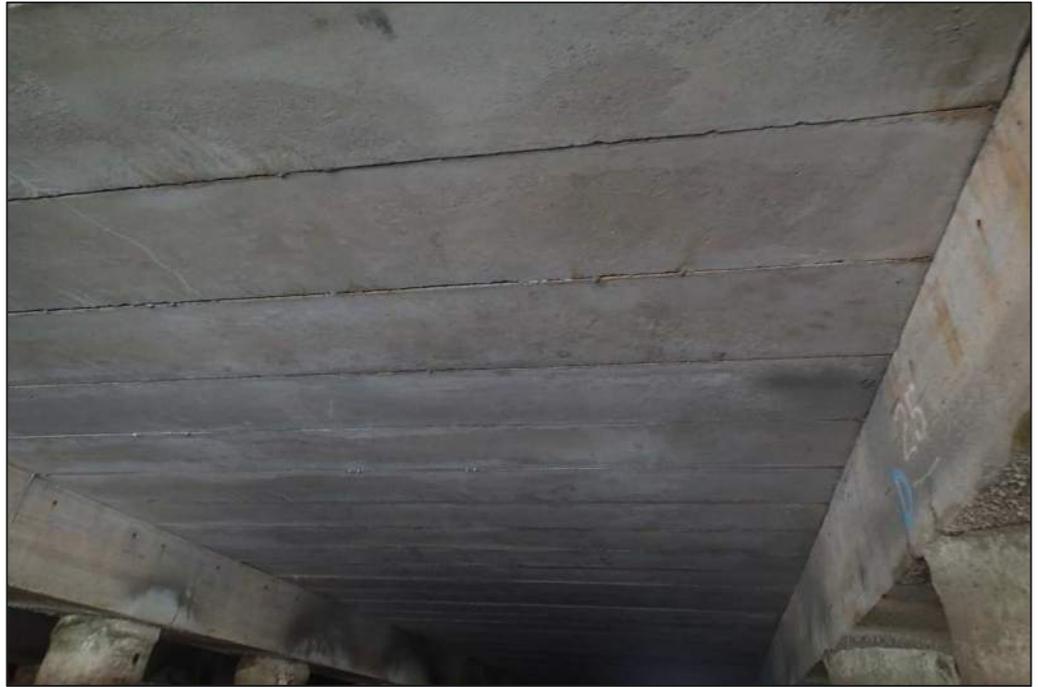
*Photograph 3 – Typical pile cap and deck plank system.*

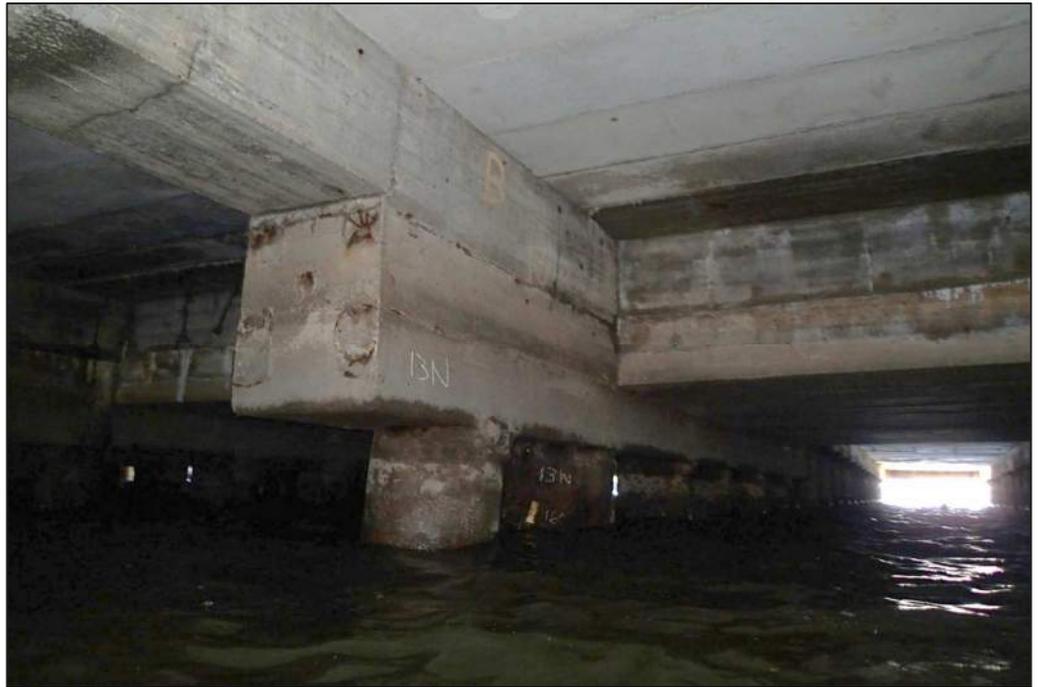
*Photograph 4 – Pile cap system below RR Well at Bent 13N.*

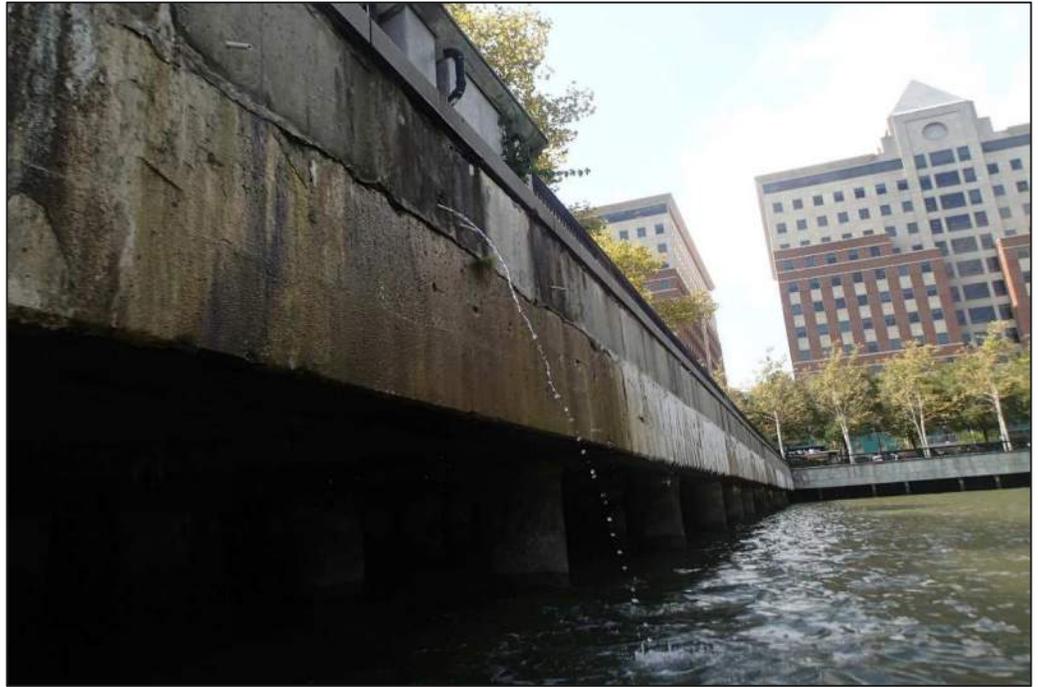
A cast-in-place reinforced concrete edge beam and fender girder, as noted in the reference drawings, spans along the northern and southern perimeters of the pier (See Photograph 5). No fendering is in place along the perimeter of the pier. Reference drawings detail that all fendering was scheduled to be removed during the 1996 rehabilitation effort.

*Photograph 5 – Typical Edge beam (looking southwest).*

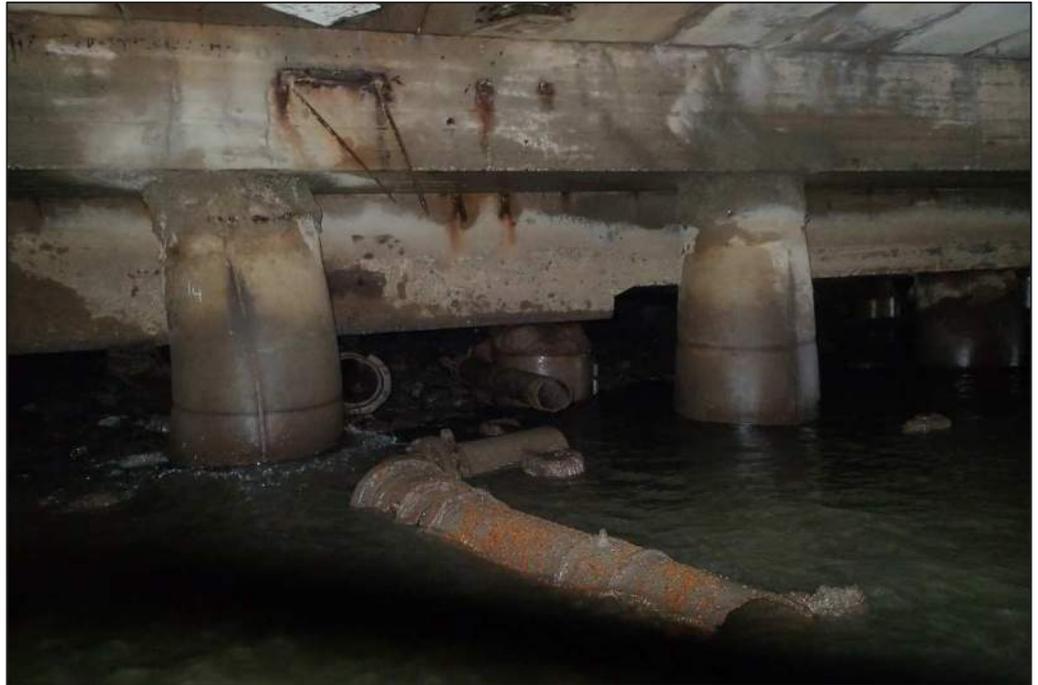
Bag encasement are present at Bents 9N/S, 10N/S, 11N/S, and 44N/S (See Photograph 6). At Bents 9N/S, 10 N/S, and 11 N/S, bag encasements were likely utilized as an alternative repair due to the difficult subsurface conditions, which made excavation problematic. Additionally, they may have been utilized due to limited clearance between the pile cap and the mudline. At Bent 44N/S, bag encasements may have been installed during or after the rehabilitation effort to span between the bottom of the encasement and the mudline.

*Photograph 6 – Typical Bag Forms at Bent 11N (looking west).*
